# NH Volunteer Beach Profiling Report 2020

## 📍 North Hampton State Beach, NH

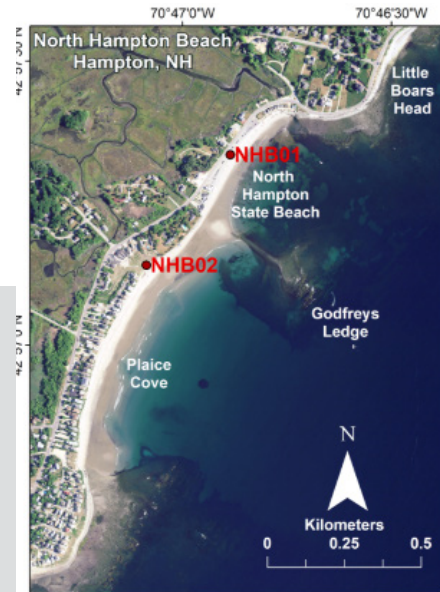
**NHB01** North Hampton State Beach is strongly affected by two landmasses, Little Boar's Head to the north and Godfreys Ledge to the south (see map). Overall, the beach at profiling station NHB01 is narrow, steep, and can change very quickly. The beach is often covered with a thin layer of sand during accretional conditions, but during erosional periods the sand veneer is easily eroded, revealing cobbles and boulders. During major storms, these cobbles and boulders are pushed up forming a ramp against the concrete seawall.

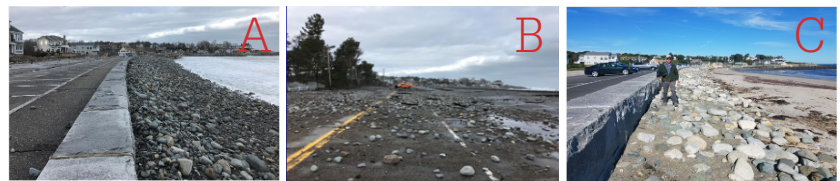
### Changes in sand volume at NB01

Each blue line represents the estimated volume of sediment measured along a 1-meter-wide swath of the beach for each given date at NHB01. A series of storms in Mar 2018 caused major erosion. The beach recovered for a period of ~7 months but a second cycle of erosion occurred in Dec 2018 and Jan 2019 due to winter storms. This erosional cycle left the beach at some of the lowest volumes recorded during the study period at NHB01. The beach regained volume quickly following these storms and reached its maximum volume in Aug 2019. The beach reached its minimum volume in Jan 2020 (likely due to two strong storms in Dec 2019), but again recovered quickly. When sediment volume is lower, the coast is more vulnerable to storm impacts such as flooding and overwash. High volumes of sediment on the beach can help combat storm damages, but in Mar 2018 high volumes of sediment were pushed against the base of the seawall resulting in overwash and damage to infrastructure.
